Contract #: 04-0120F4Cty: SF/ALA Rte: 80 PM: 13.2/13.9File #: 13.28**WELDING INSPECTION REPORT****Resident Engineer:** Pursell, Gary**Address:** 333 Burma Road**City:** Oakland, CA 94607**Report No:** WIR-009777**Date Inspected:** 23-Oct-2009**Project Name:** SAS Superstructure**OSM Arrival Time:** 1500**Prime Contractor:** American Bridge/Fluor Enterprises, a JV**OSM Departure Time:** 2330**Contractor:** Oregon Iron Works Clackamas, Or.**Location:** Clackamas, OR**CWI Name:** Steve Barnett**CWI Present:** Yes No**Inspected CWI report:** Yes No N/A**Rod Oven in Use:** Yes No N/A**Electrode to specification:** Yes No N/A**Weld Procedures Followed:** Yes No N/A**Qualified Welders:** Yes No N/A**Verified Joint Fit-up:** Yes No N/A**Approved Drawings:** Yes No N/A**Approved WPS:** Yes No N/A**Delayed / Cancelled:** Yes No N/A**Bridge No:** 34-0006**Component:** Hinge-K Components**Summary of Items Observed:**

Hinge-K Pipe Beam Base Assembly 102A-2:

# WELDING INSPECTION REPORT

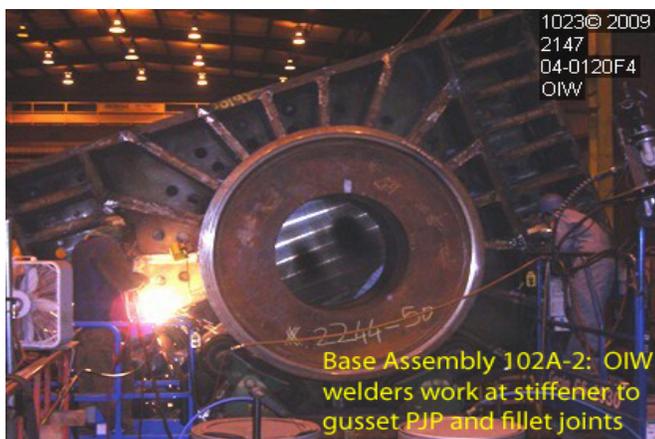
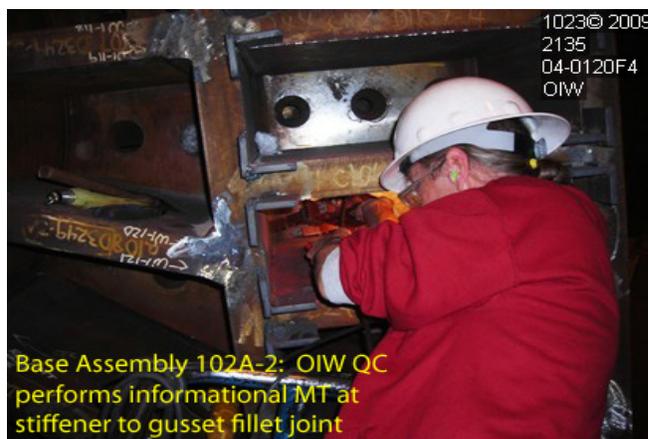
The QA Inspector intermittently monitored OIW welders Vincent Vu (WID V7) and Bounehoun Savahn (WID S74) during in progress Submerged Arc Welding (SAW) at weld joints W1-95 & W1-97 and W1-122 & W1-10 respectively. The referenced connections join various stiffeners to a107 gussets. The QA Inspector observed as OIW QC Inspector Steve Barnett performed Magnetic particle Testing (MT) and Visual Inspection (VT) of completed root pass at weld joint W1-97 referenced above. Mr. Barnett stated that he had located no rejectable indications. The QA Inspector subsequently performed 100% VT & 50% MT verification at the noted location finding the root pass to be in general compliance with contract documents. Please reference TL-6028 report for this date for details. The QA Inspector intermittently observed as welders V7 & S74 deposited SAW passes in the horizontal (2G/F) position in accordance with approved welding procedure 4020. The QA Inspector noted the OIW welders were maintaining continuous preheat utilizing a torch. The QA Inspector observed OIW QC Inspector Steve Barnett regularly monitoring and recording the in process SAW parameters. The QA Inspector also intermittently observed in process welding parameters and determined that the SAW parameters and minimum preheat/interpass temperature appeared to be in general compliance with the contract requirements --

(W1-97: 35 volts, 563 amperes, 432mm/min travel speed).

The QA Inspector noted that one OIW employee was engaged in primer application at interior of Assembly 120A-7 intermittently for the duration of the shift.
